Flight Motor Set 360H005 (STS-28R) Final Report

**Volume V
(Nozzle Component)**

September 1990

***Thiokol* CORPORATION
SPACE OPERATIONS**

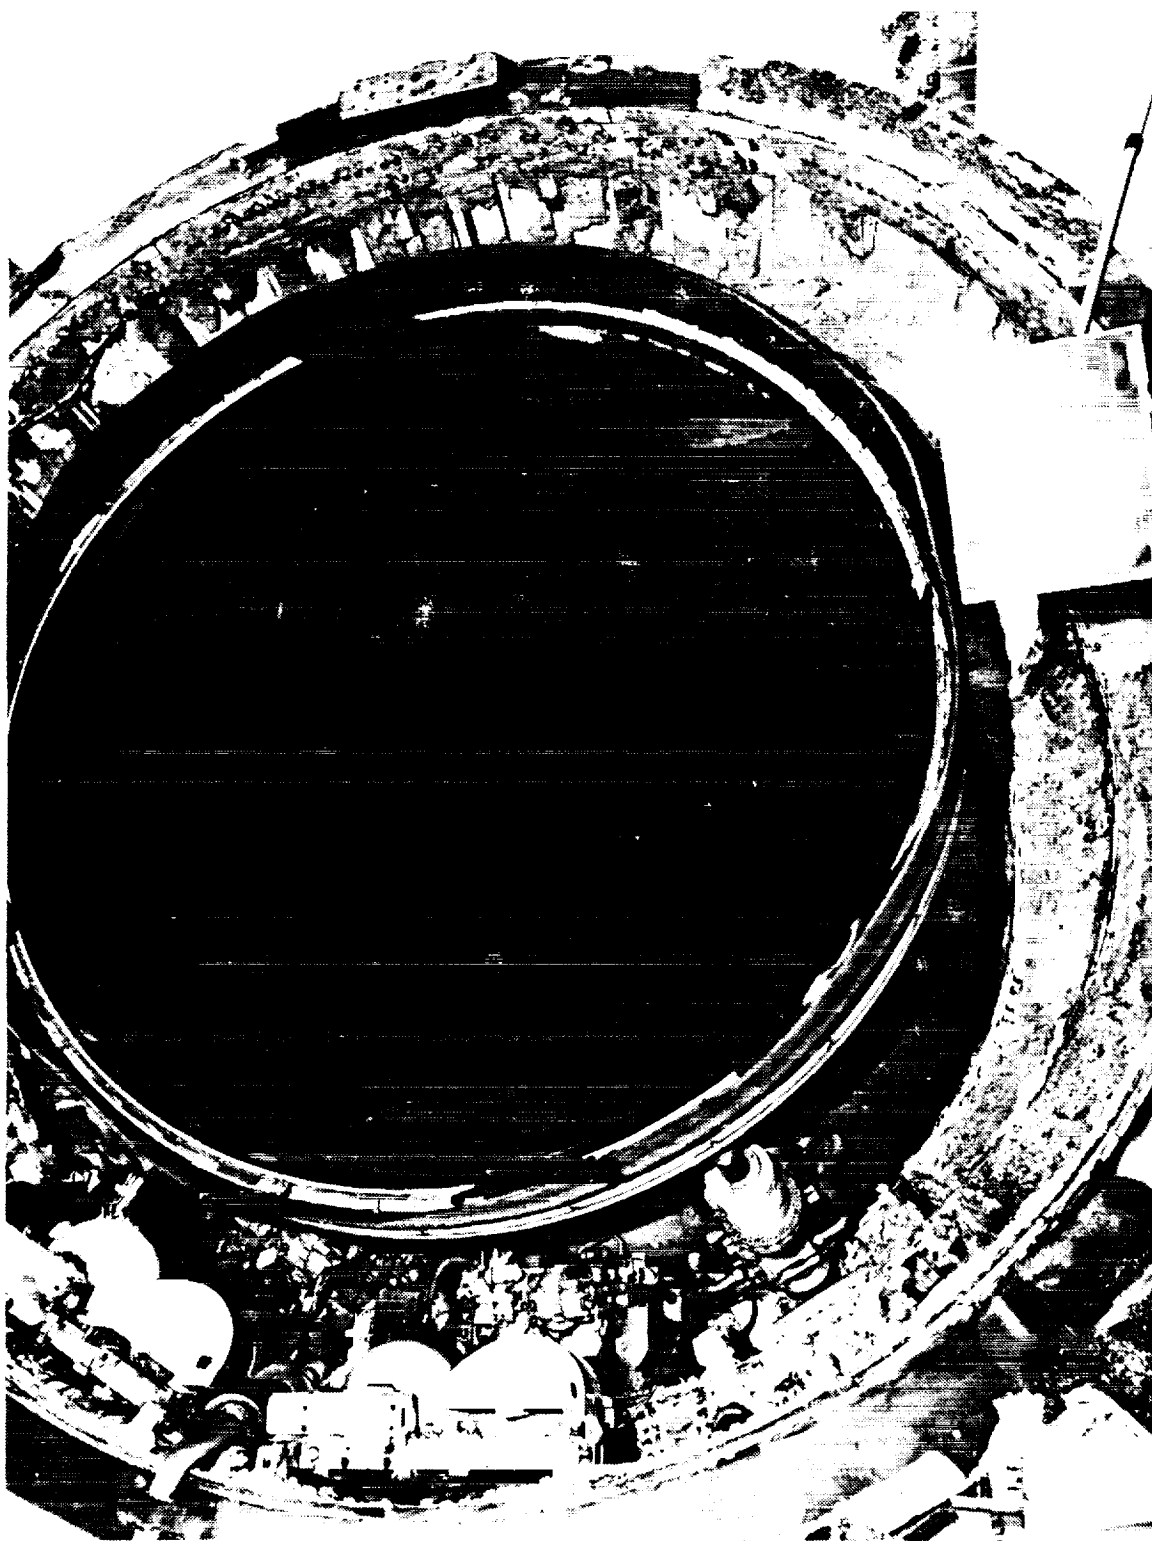
Figure 7 STS-28A Aft Exit Cone Fragment

The aft exit cone was severed aft of the compliance ring by the LSC. The nozzle severance system performance was nominal. The exit cone cut was clean, with no unusual tearing or breaking. The remaining aft exit cone fragment showed missing CCP liner 360 degrees circumferentially. This is a typical postflight observation and occurs at LSC firing and at splashdown. Glass Cloth Phenolic (GCP) plies exposed by the missing liner showed no signs of heat effect. A void in exposed EA946 adhesive was found at approximately 80 degrees and measured 3 inches axially by 1 inch circumferentially. There was no metal exposed at this location.

A small pin-hole, approximately 0.010 inch in diameter, was found in the polysulfide at 268 degrees. This was 0.10 inch inboard of the aft exit cone shell. A small fiber, believed to be GCP, was embedded in the pin-hole. A foreign residue was also found on the surface of the polysulfide from 265 to 271 degrees. The residue was determined to be silica and silicon with small traces of salt.

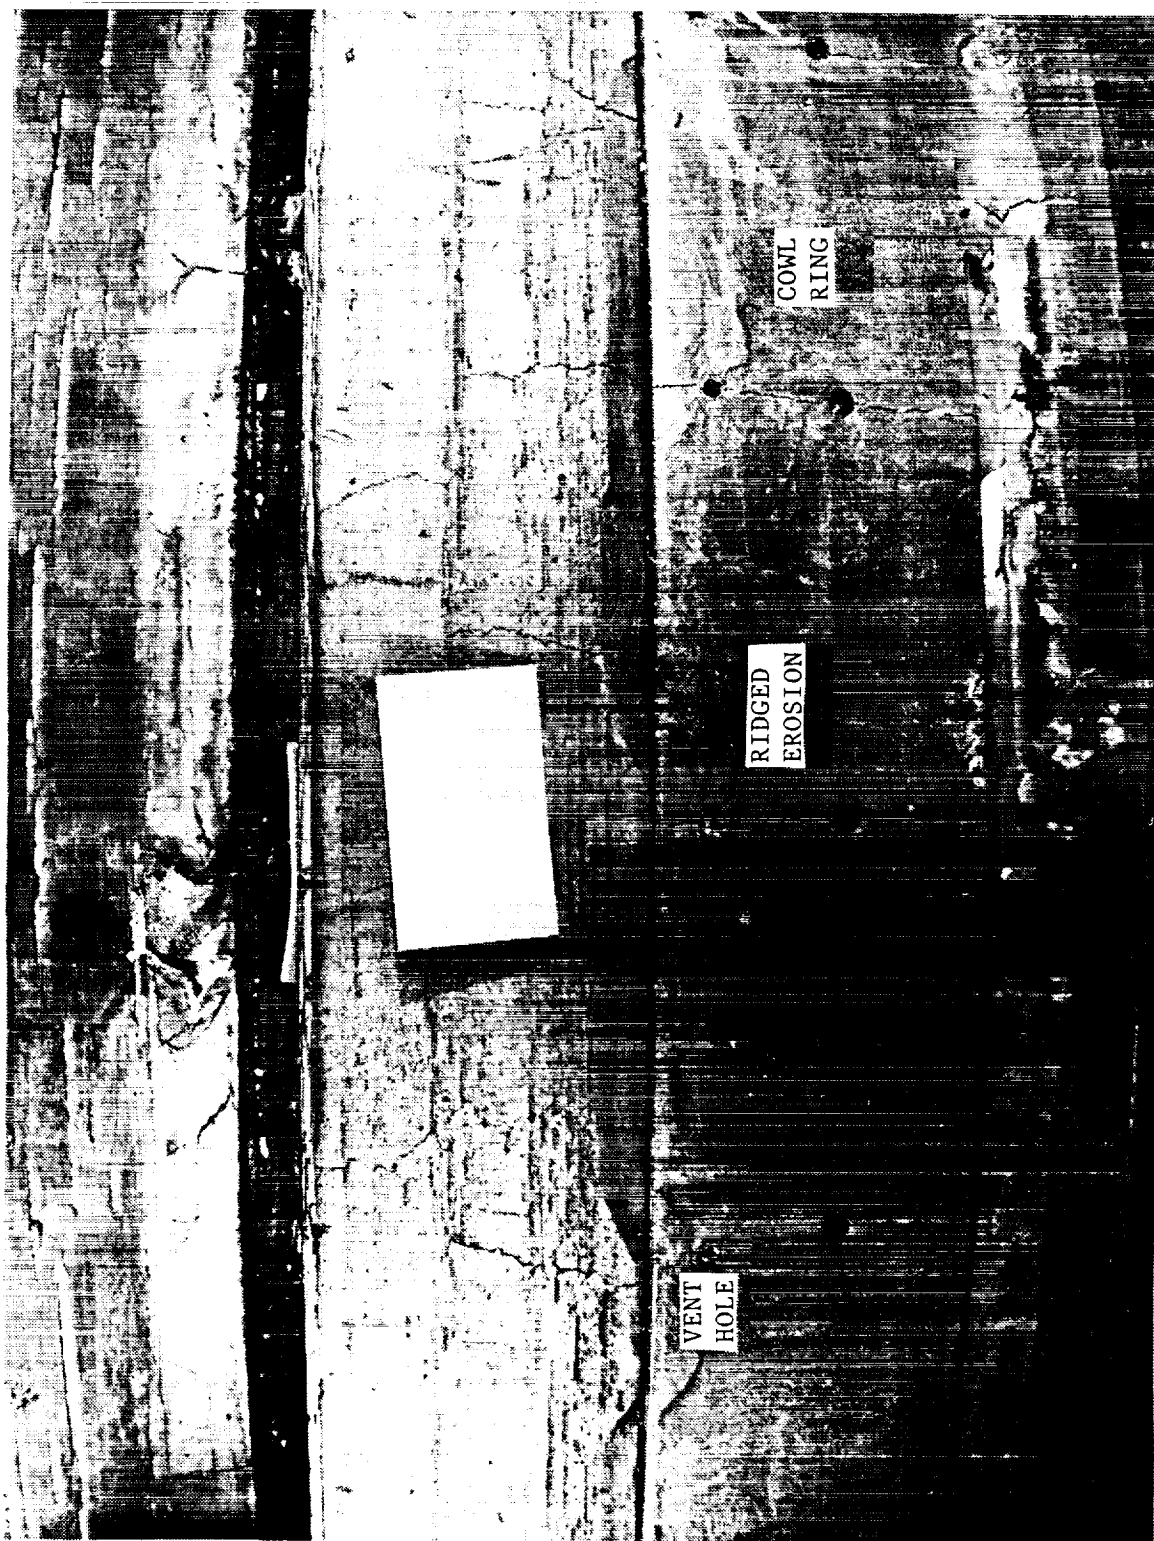
Figure 30 STS-28A Cowl/OBR Closeup (0 deg)

The structural backup OBR was intact. The flow surfaces showed smooth erosion with no pockets or wedgeouts. Intermittently, minor wash areas extended from the cowl to the forward 1 inch of the OBR. Postburn, popped-up charred CCP was found on the forward 2 inches intermittently. The OBR aft end showed typical delaminations along the charred CCP plies. The aft tip adjacent to the flex boot was fractured and wedged out intermittently around the circumference. Sharp edges on the surfaces indicate this occurred after motor operation.

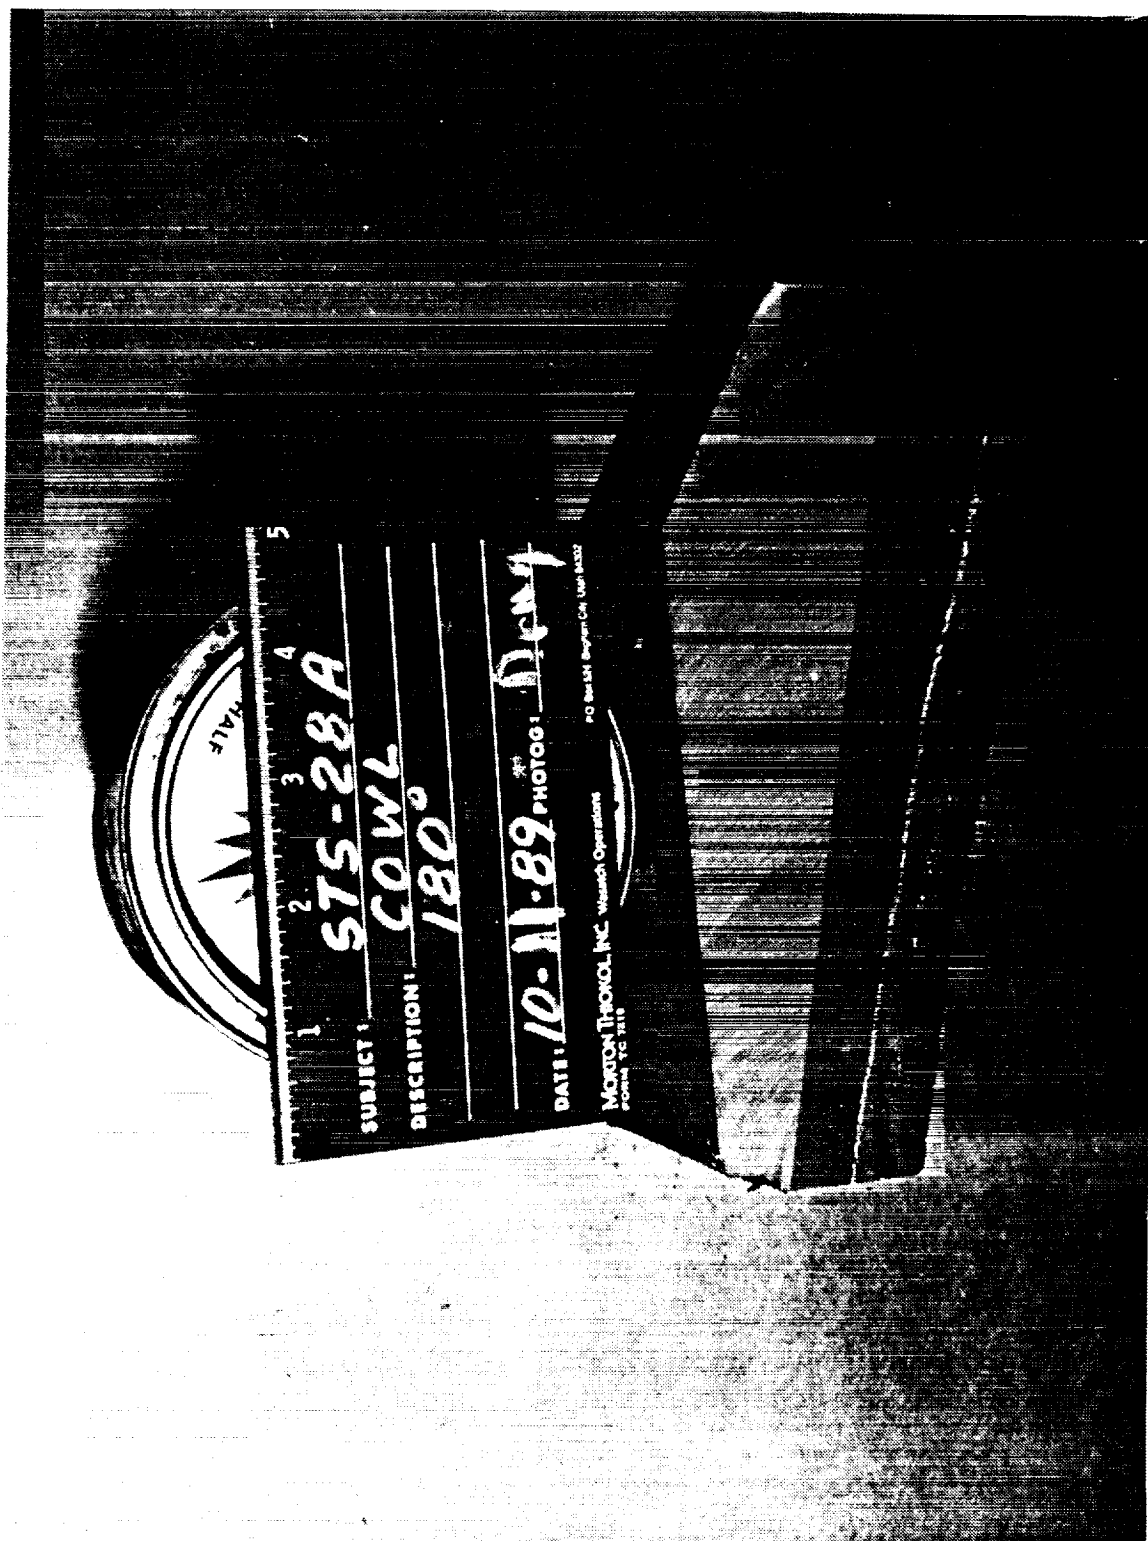
Figure 36 STS-28A Cowl Ring Section (180 deg)

Typical ridged erosion was observed intermittently around the cowl circumference. The forward portion of the ring eroded a maximum of 0.15

inch greater than on the aft portion of the ring. This is a result of the low ply angle of the cowl ring and has been observed on the majority of flight and static test nozzles. Postburn wedgeouts and popped-up CCP were observed on the aft 3-to-4 inches intermittently around the circumference.

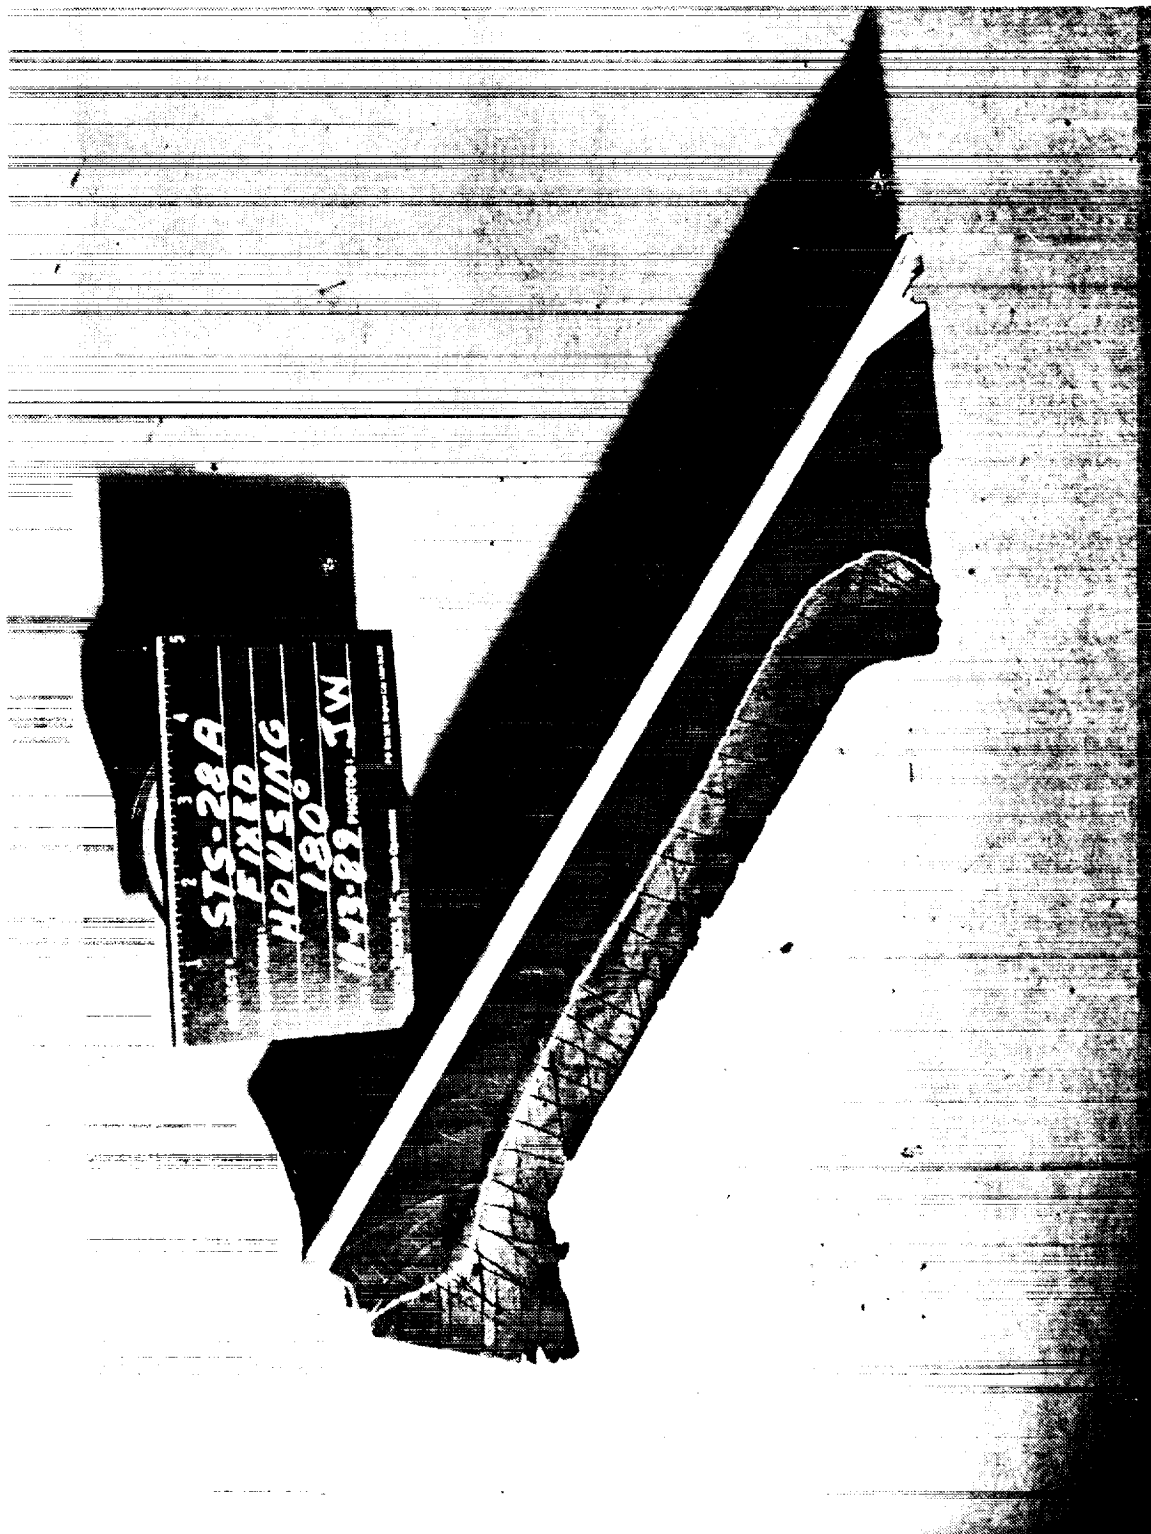
Figure 48 STS-28A Fixed Housing Section (180 deg)

Separations were observed on the aft end of the fixed housing between the metal and EA913 NA adhesive at 227 degrees, between the adhesive and GCP at 235 degrees, and within the adhesive at 110 and 230 degrees. All separations measured 0.005 inch radially.

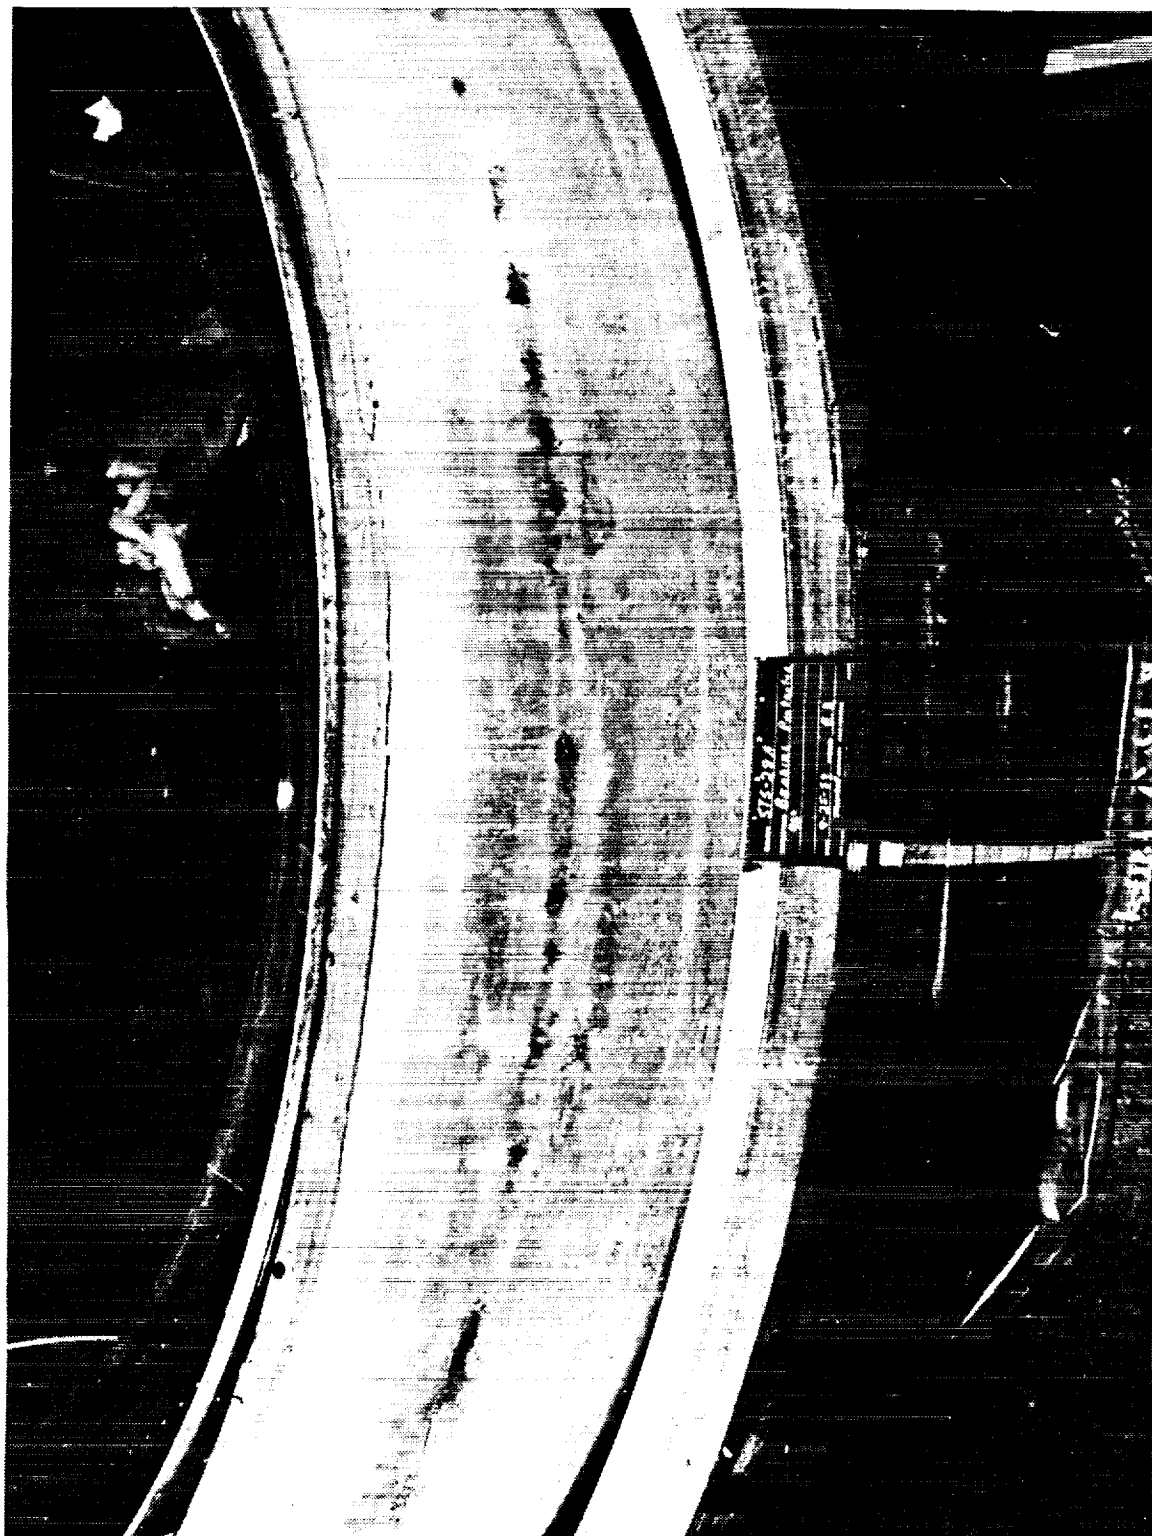
Figure 52 STS-28A Bearing Protector (90 deg)

The bearing protector was sooted along the entire length and circumference (Figures 51 through 53). Slightly heavier soot and erosion were observed in line with the cowl ring vent holes at the thickened portion, but there was no bearing protector burn-through. The largest erosion was 0.162 inch at 90 degrees. There was no evidence of heat effect on the Inside Diameter (ID) surface of the bearing protector.
